CALSPAN ON-SITE AIR BAG DEPLOYMENT INVESTIGATION

CALSPAN CASE NO. 90-14

FLEET - 1990 DODGE DYNASTY

ACCIDENT DATE - [REDACTED] 1990

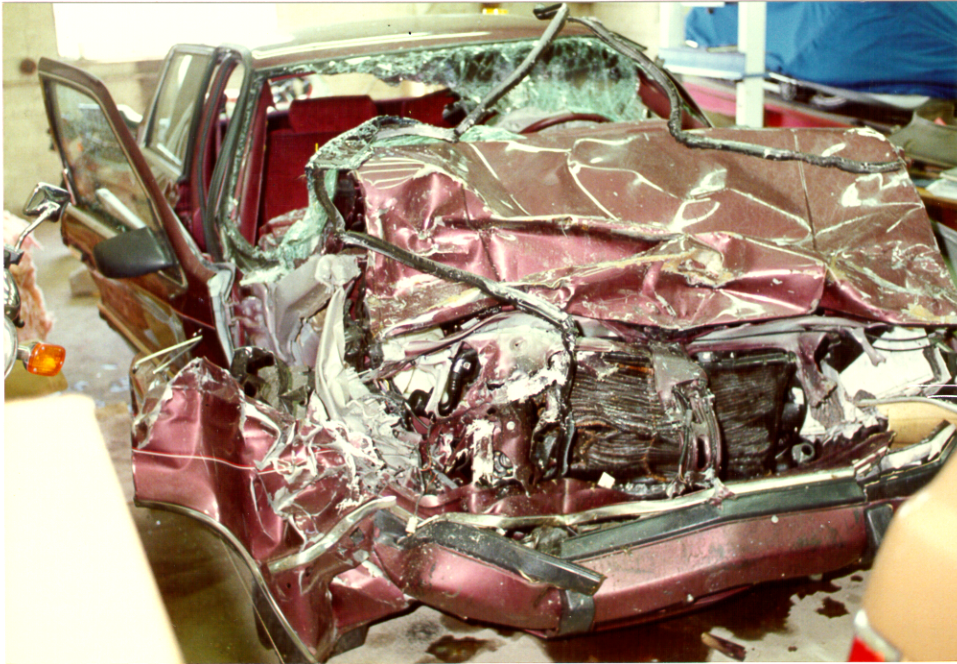
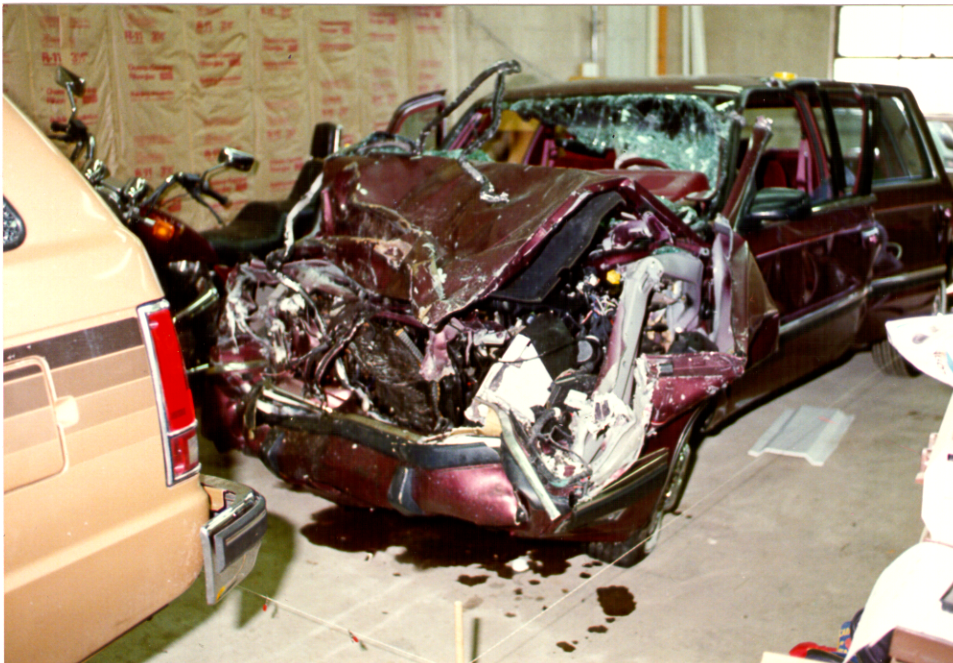
Frontal Views Of The Dodge Dynasty

## VEHICLE DAMAGE

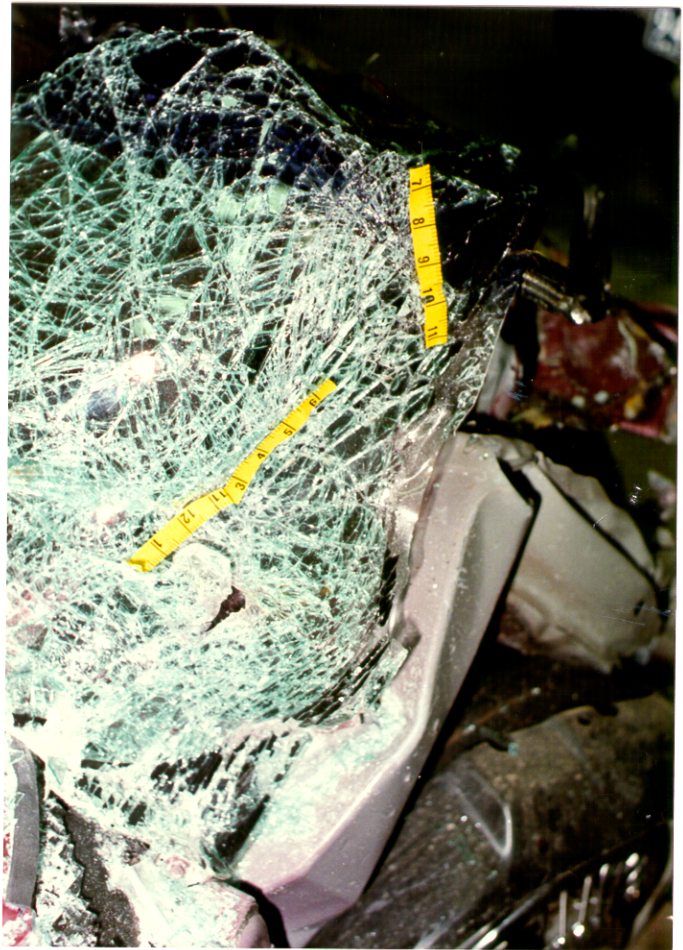
Passenger Head And Face  
Contacts To The Right  
A-Pillar and Windshield

Interior of center and involved a 6.5" diameter area of depression  
(Air Bag with a maximum depth of .75". The passenger's head and  
Vehicle) face struck the right A-pillar (scuff mark) and windshield.  
(Cont'd.): Hair and tissue deposits were noted to the windshield  
2.5 - 4" inboard of the pillar and 5 - 17" below the windshield  
header. There was also a U-shaped tear of the plastic laminate  
at the lower portion of the tissue deposit.

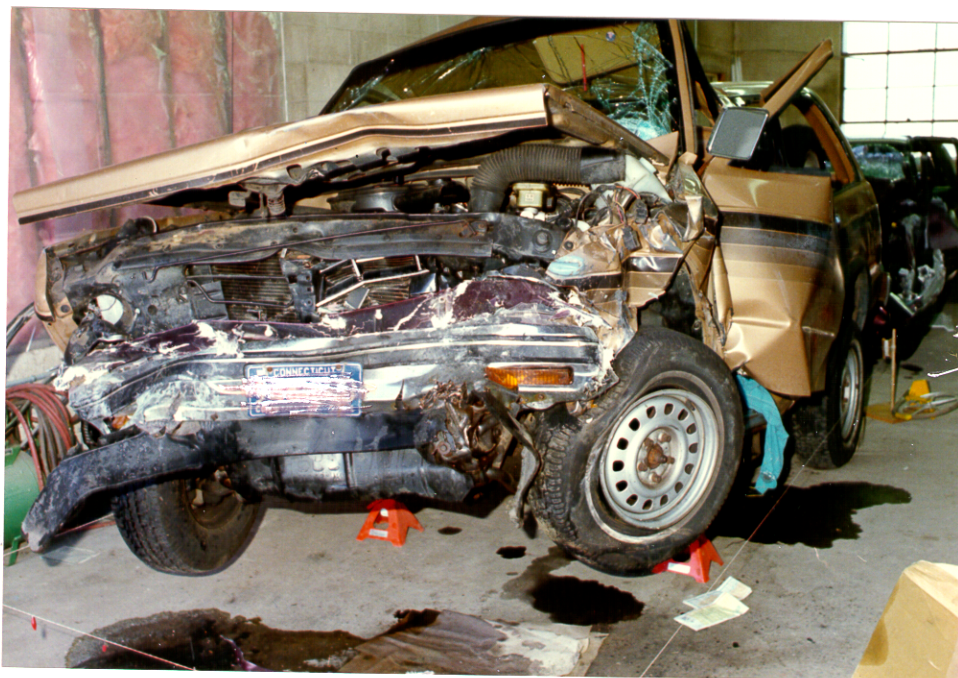
Left Front Three-Quarter View

The S-10 Blazer sustained 35.25" of crush located at the left corner of the front bumper. The Blazer's crush profile at bumper level was as follows:  $C_1=35.25"$ ,  $C_2=33.0"$ ,  $C_3=26.6"$ ,  $C_4=19.75"$ ,  $C_5=15.5"$ ,  $C_6=13.6"$ . The damage mode of the CRASHPC program computed velocity changes of 41.7 mph for the Dynasty and 40.7 mph for the S-10 Blazer. As a result of the impact induced deceleration, the Dynasty's driver air bag system deployed.
